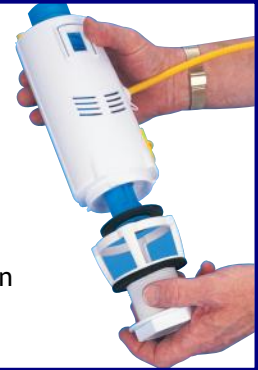
1. Check that the blue overflow pipe movement is not restricted i.e. hitting underside of cistern lid. Does it work fine with cistern lid off?
2. Remove the white block from the back of the button. Is the button still difficult? If yes, loosen the button-securing nut slightly.
3. If fitted to a 38mm hole check for good clearance and that there is no debris from the drilling operation preventing free movement of button.
4. Check that the blue overflow tube slides up and down freely prior to attaching button block.
5. Check that the cable is not twisted, kinked or caught.
